Manhole Inspection Summary

Manhole # S15MM_007MH

Location Address: **COPPIN STATE U CAMPUS** Cross Street: **WARWICK AVE**

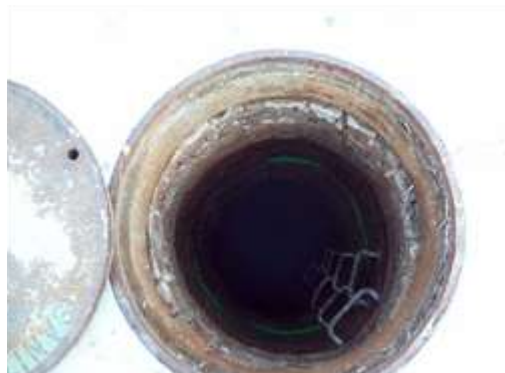
Top View

Chimney / Frame Adjustment ☒ Exists Material: **Brick** ☐ Parged Height: **11** (in.)
Condition: ☐ Sound ☒ **Cracked** ☐ Root Intrusion ☒ **Loose Brick** ☐ Deteriorated
Infiltration: ☒ None ☐ Joint ☐ Cracks ☐ Mortar ☐ Roots ☐ Wall

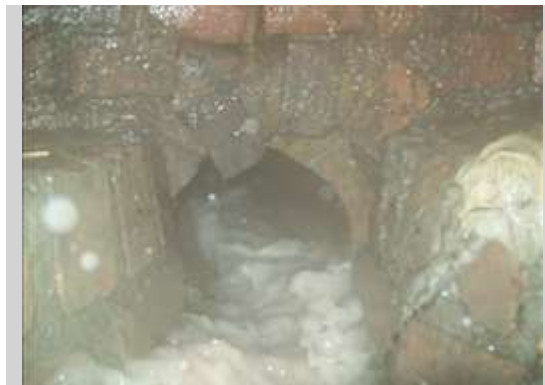
Pipe Out @ 12 O'Clock

Pipe Material: **Clay** ☐ Pipe Lined

Invert Depth: **30.00** (ft.) Flow Characteristics: **Fast**

Infiltration: **None** Pipe Seal Cond: **Sound**

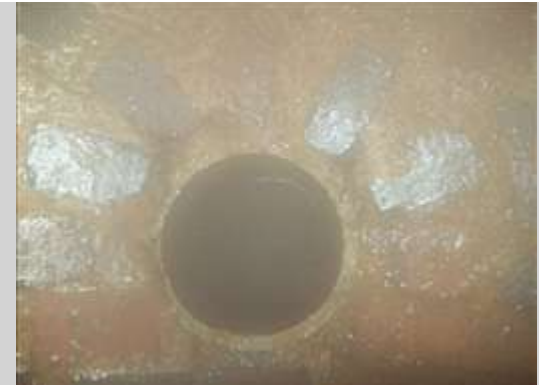
Pipe In @ 3 O'Clock

Pipe Material: **Clay** ☐ Pipe Lined

Invert Depth: **20.70** (ft.) Flow Characteristics: **Fast**

Infiltration: **None** Pipe Seal Cond: **Sound**

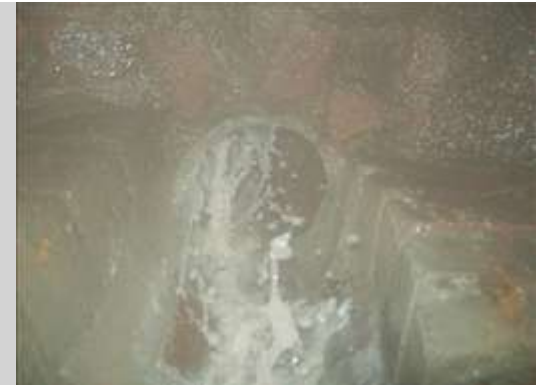
Drop In @ 3 O'Clock

Drop: **Outside Direct**

Inv Depth: **30.10** (ft.)

Drop Condition: **Open**

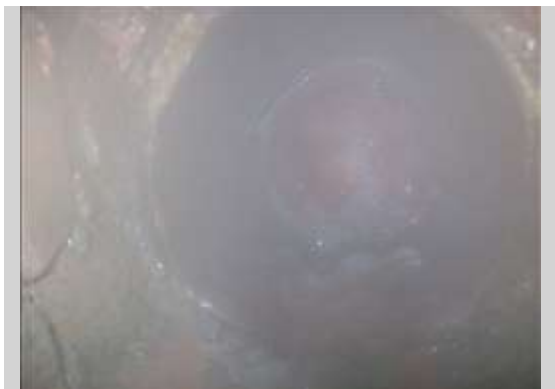
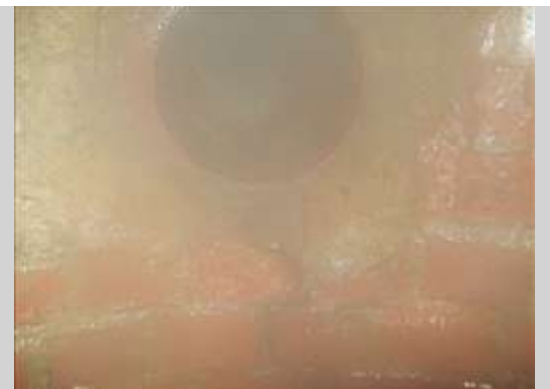
Pipe In @ 6 O’Clock

Pipe Height: (in.) Direct
Pipe Material: **Clay** ☐ Pipe Lined
Invert Depth: **15.73** (ft.) Flow Characteristics: **Fast**
Deposits: ☒ None ☐ Mud ☐ Sludge ☐ Debris ☐ Grease
Silt Depth: (in.) Deposits Extent:
Infiltration: **None** Pipe Seal Cond: **Sound**

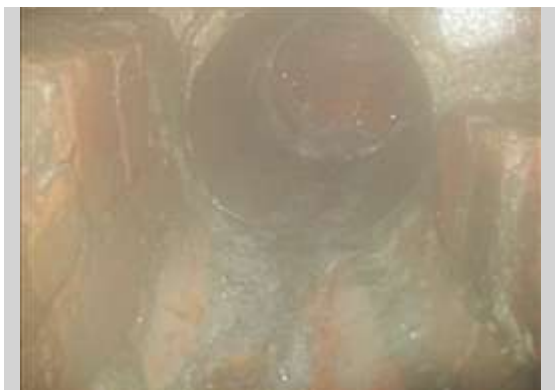
Drop In @ 6 O’Clock

Drop: Outside Direct	
Angled:	Reading: (ft.)
Inv Depth: 30.18 (ft.)	
Drop Condition: Open	
Connects To: Manhole	
<input type="checkbox"/> Possible Illicit Connection

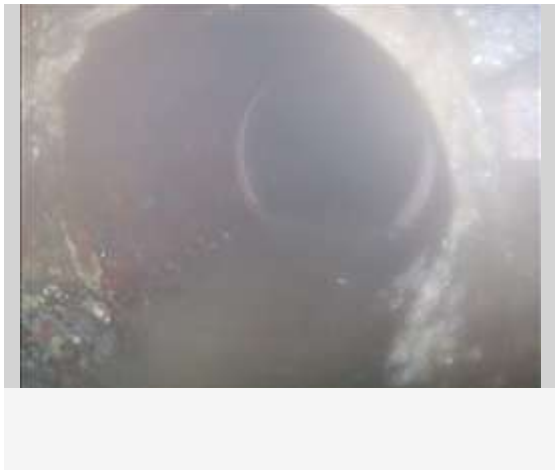
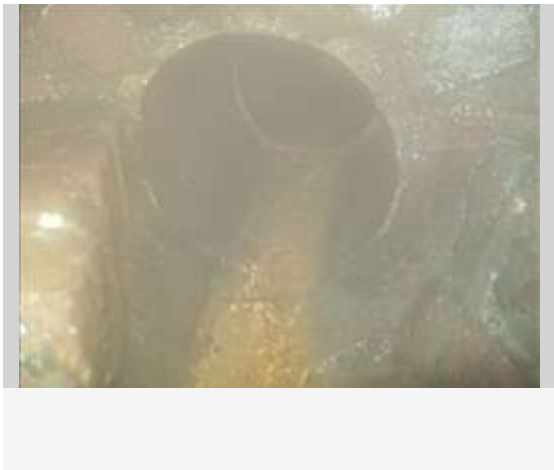
Pipe In @ 9 O'Clock

Pipe Height:	(in.)	Direct	
Pipe Material:	Clay	<input type="checkbox"/> Pipe Lined	
Invert Depth:	30.00	(ft.)	Flow Characteristics: Slow
Deposits:	<input checked="" type="checkbox"/> None	<input type="checkbox"/> Mud	<input type="checkbox"/> Sludge
		<input type="checkbox"/> Debris	<input type="checkbox"/> Grease
Silt Depth:	(in.)	Deposits Extent:	
Infiltration:	None	Pipe Seal Cond:	Sound
		Drop: None	
		Connects To: House connection / Service line	
		<input type="checkbox"/> Possible Illicit Connection
